TOMOS A35

workshop manual

colibri
TOMOS A35

TOVARNA MOTORNIH VOZIL
TOMOS KOPER
SLOVENIA

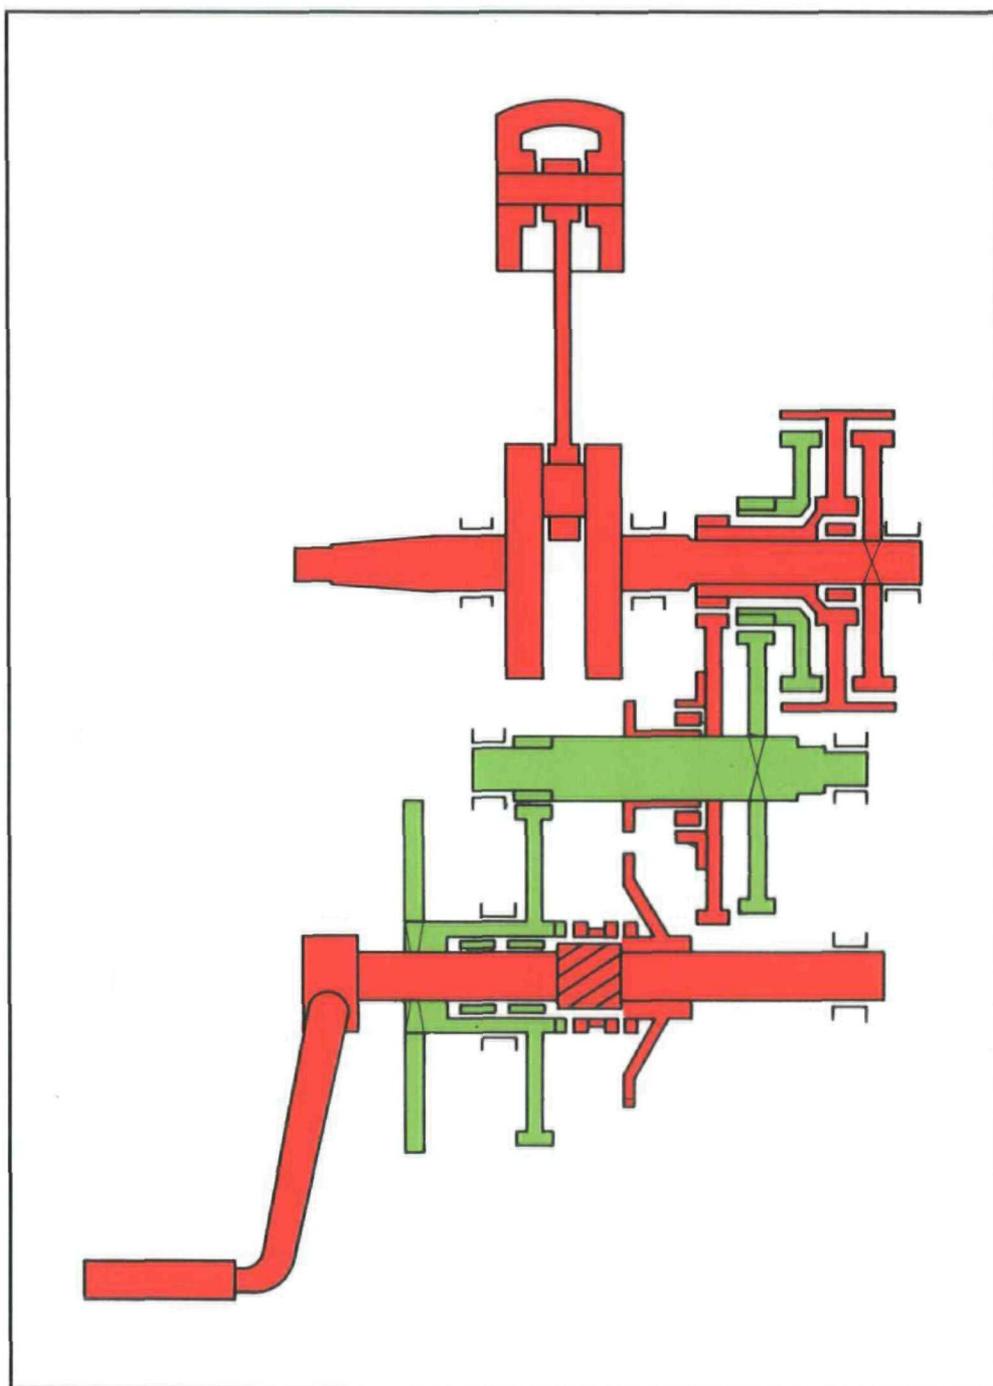
Starting

- rotating powered elements
- free rotating elements
- stand still elements

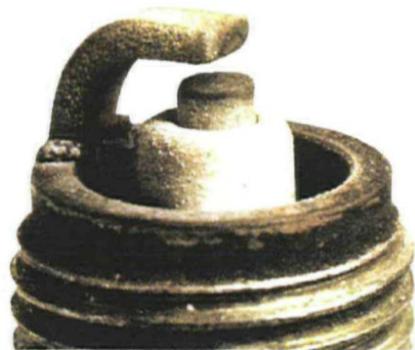
A brown, tan or gray firing end is indicative of correct engine running conditions and the selection of the appropriate heat rating plug.

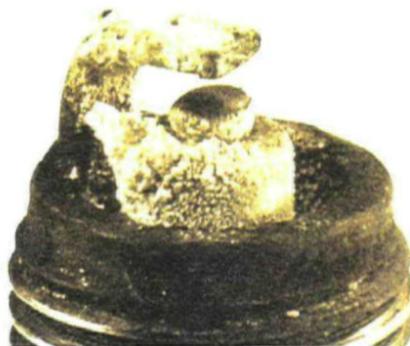
White deposits have accumulated from excessive amount of oil in the combustion or through the use of low quality oil. Remove deposits or a hot spot may form.

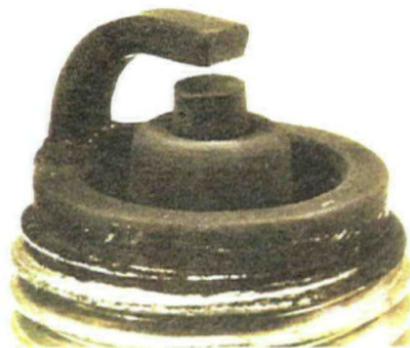
Black sooty deposits indicate an over-rich fuel /air mixture, or a malfunctioning ignition system. If no improvement is obtained, try one grade hotter plug.

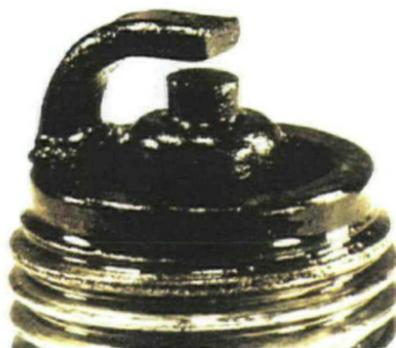
Wet, oily carbon deposits form an electrical leakage path along the insulator nose, resulting in a misfire. The cause may be a badly worn engine or a malfunctioning ignition system.

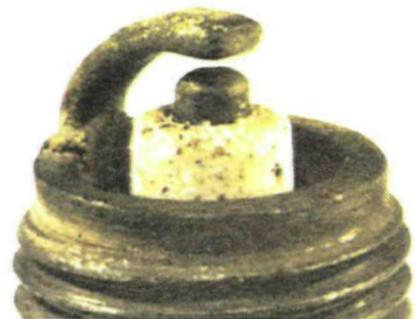
A blistered white insulator or melted electrode indicates over advanced ignition timing or a malfunctioning cooling system. If correction does not prove effective, try a colder grade plug.

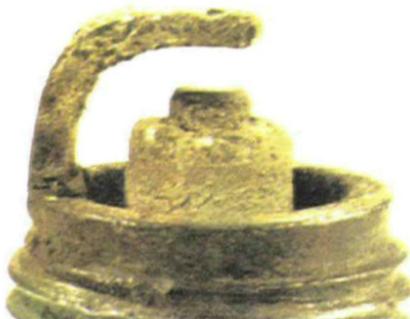
A worn spark plug not only wastes fuel but also overloads the whole ignition system because the increased gap requires higher voltage to initiate the spark. Adjust spark plug gap or replace.

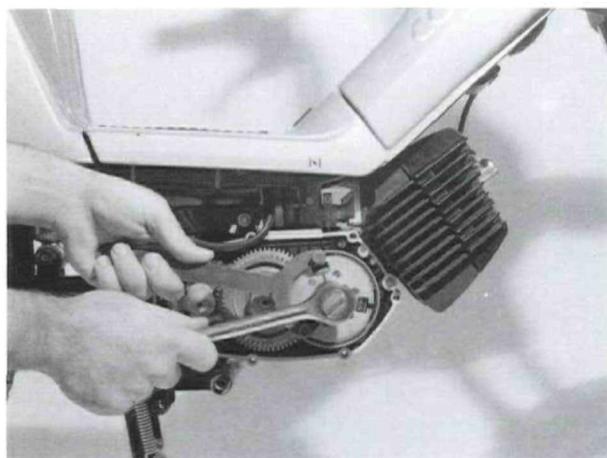
Fig. 1

Slacken the protective clutch washer with a socket 19 and with special tool 732.202 remove 1st speed clutch nut (fig. 1).

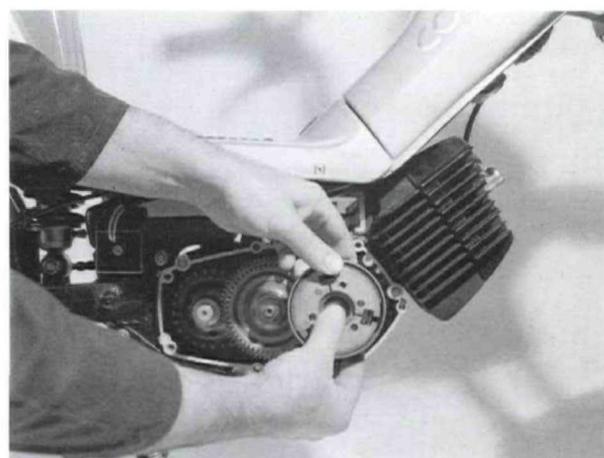
Fig. 2

Detach clutch drum by hand or by means of an standard extractor in case of bushing seizure (fig. 2).

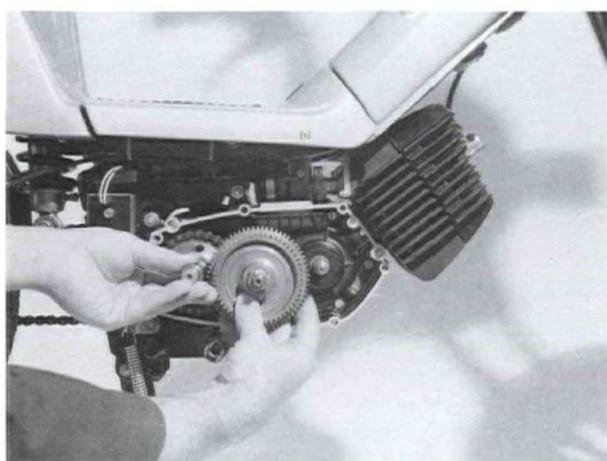
Fig. 3

The starter shaft and the countershaft are connected by a starter chain, so both shafts will have to be taken out together (fig. 3).

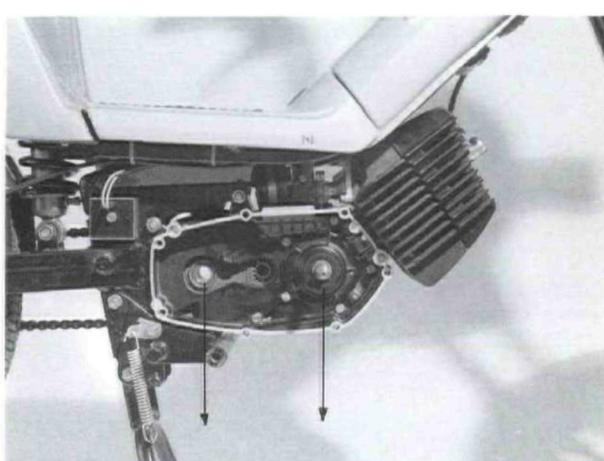
Fig. 4

Remove the standard washers on the crankshaft and on the mainshaft (fig. 4).

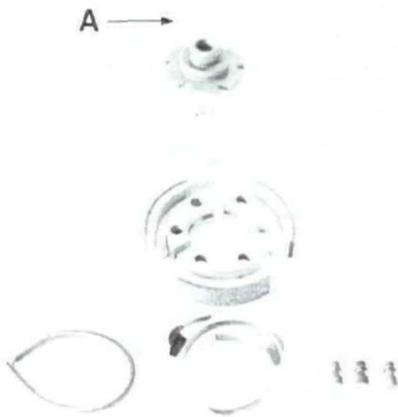
Fig. 5

Press pins out of shoes and check brake strips, spring inside of shoes and clutch hub for excessive wear (Fig. 5). Clutch shoes must slip freely on clutch hub. In case of use of prescribed oil quantity and quality the wear of clutch shoes linings is reduced at minimum.

Clearance between shoes and clutch drum rim is approx. 0,4 mm. Axial clearance of the clutch drum is from 0.1 m to 0.3 mm by means of inserting in the adjusting thrust washer of 0.3 mm or 0.5 mm under the clutch (fig. 5/A).

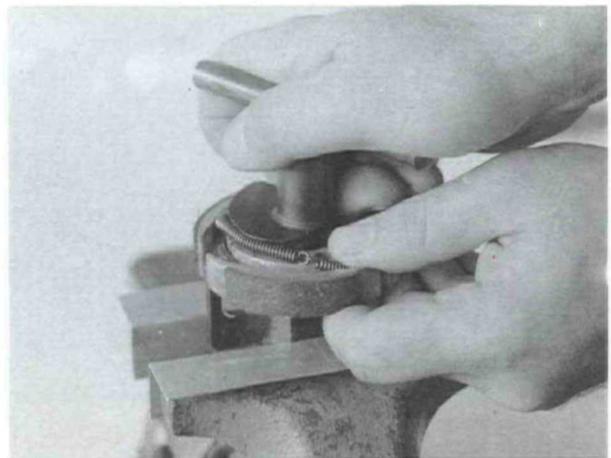
Fig. 6

Fix the main pin of the device 737.535 with the thinner part facing upwards. The spring joint must be placed in the middle of one shoe. With the lever of the device insert the spring in the shoes groove. (Fig. 6).

To assemble the 2nd speed clutch turn the device over. The clutch hub with gear must be placed in the way the gear is on bottom and the gap between two shoes fits with the pin. The manner of mounting the spring is the same as mentioned before for the 1st speed clutch.

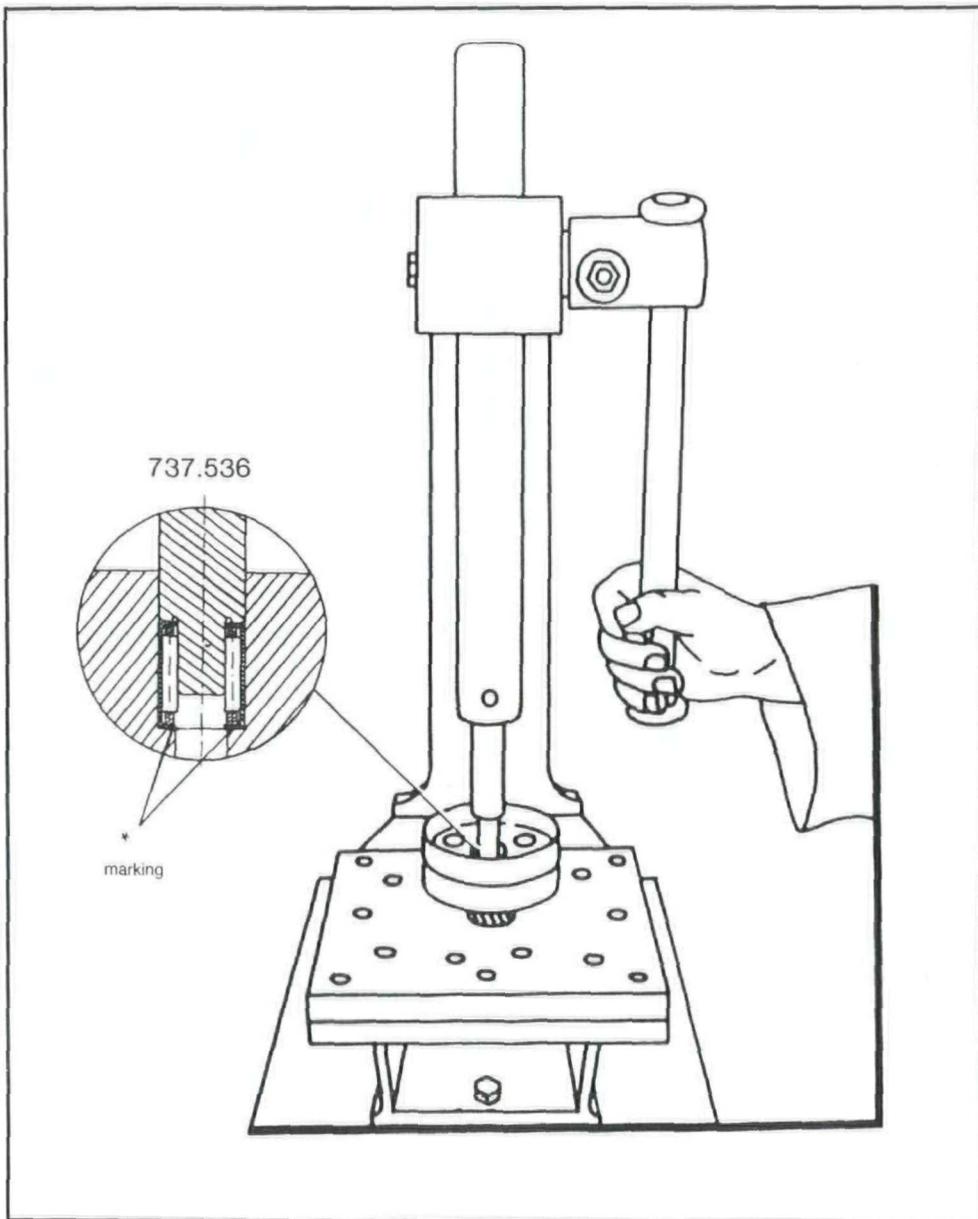
Fig. 7

A new needle clutch is pressed with special tool no. 737.536 (Fig. 7).

The needle clutch must be pressed with the signed side towards the center of the clutch drum, if not it may operate in the reverse direction.

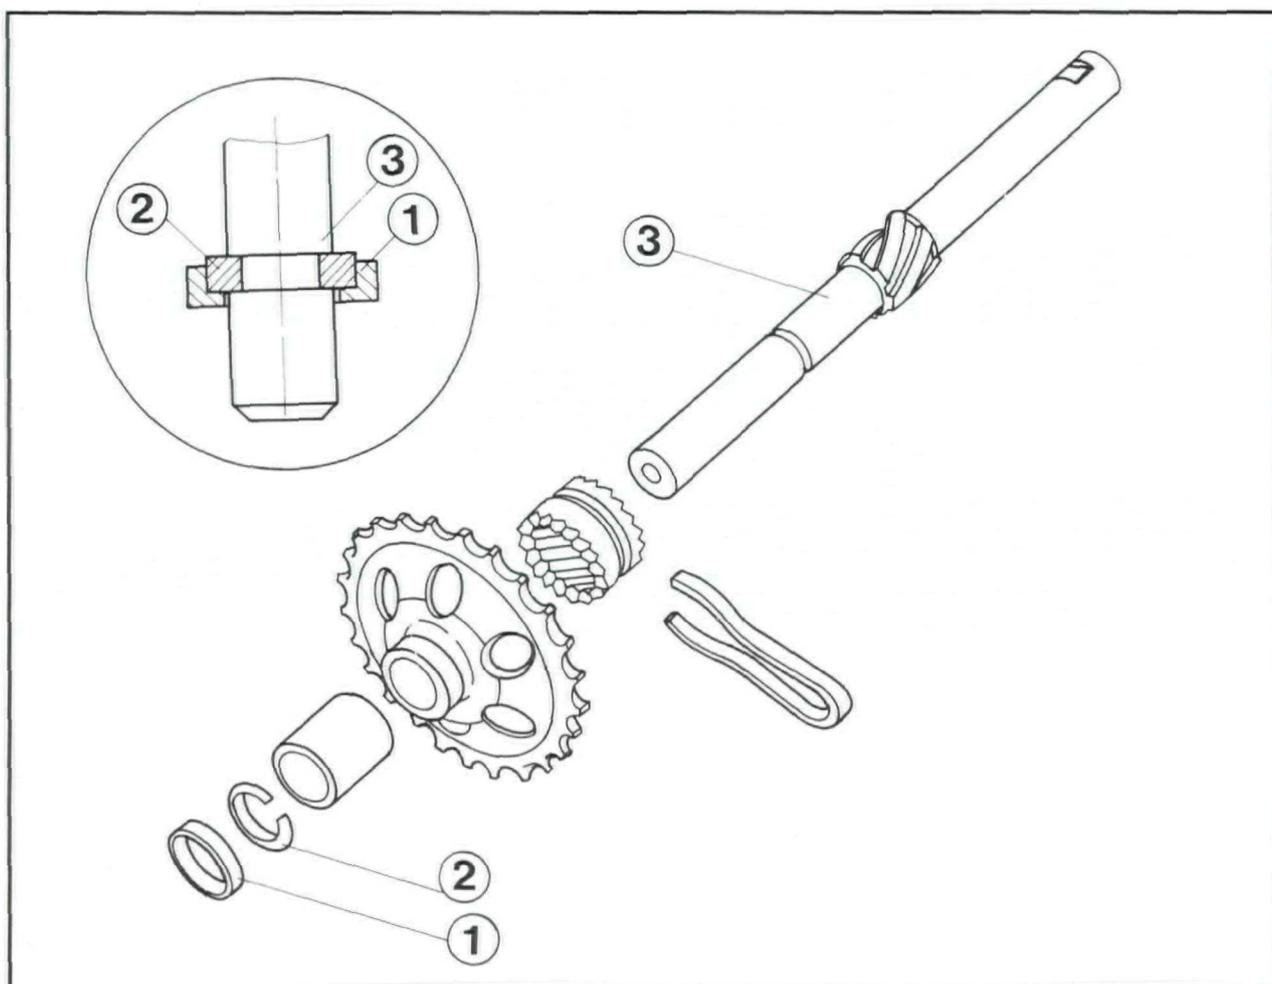
Fig. 8

If is necessary to replace chain sprocket or claw collar on pedal shaft of kick shaft, first remove protective ring (fig. 8/1) and spring washer (fig. 8/2). During assembly take care that the thinner part of collar is mounted forward or else, the brake spring slides across the chain sprocket. Check the chain for overtension or some other damage.

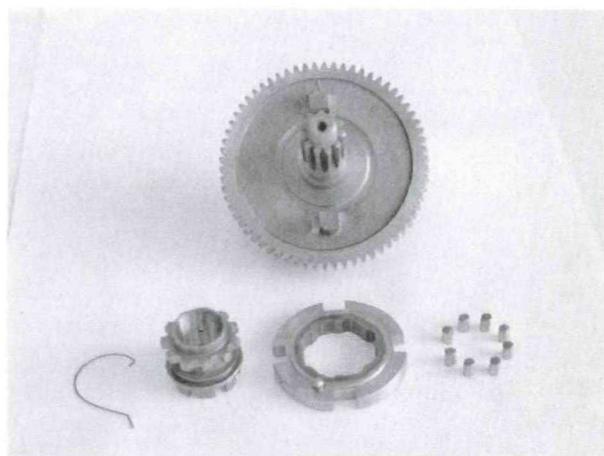
Fig. 10

Remove and inspect the 1st speed driven gear selflocking clutch in case of transmission troubles mentioned on page 24. Remove the sg-circlip at the countershafts toothing. Unfasten the wire spring (Fig. 9) and separate a small chain sprocket with roller cage. Remove the selflocking clutch and the rollers (Fig. 10).

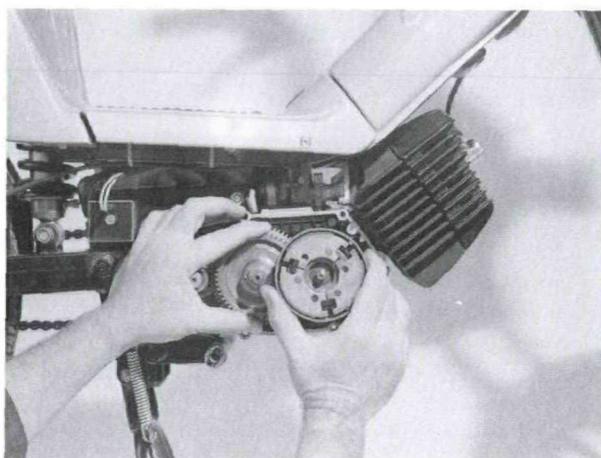
Fig. 11

Before tightening nut, it is necessary to check the proper function of the assy. Firmly hold 2nd speed driven gear with the left hand and the clutch drum with the right hand. When clutch drum rotates counterclockwise, both clutches idle, when it rotates clockwise the motion is transmitted to the crankshaft (fig. 11).

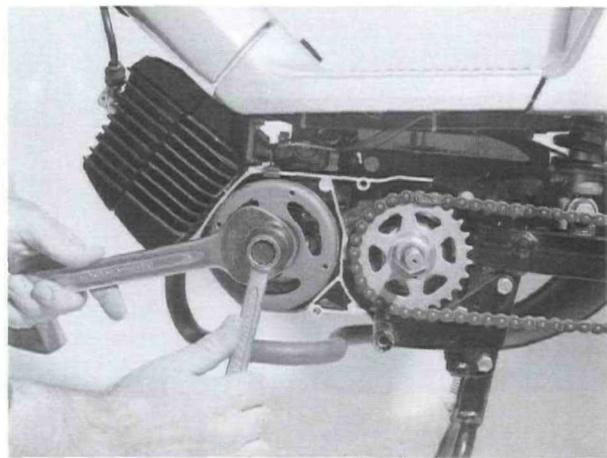
Fig. 13

- starting/lever pedal (wrench 11, plastic mallet)
- side protection shield fixed on swinging arm (wrench 10)
- engine cover (flat screwdriver)
- flywheel nut (socket wrench 17, flywheel holder=special tool 732.202=fig. 12)
- flywheel (wrench 32 and 19, flywheel extractor=special tool 732.746=fig. 13)
- stator plate (flat screwdriver)

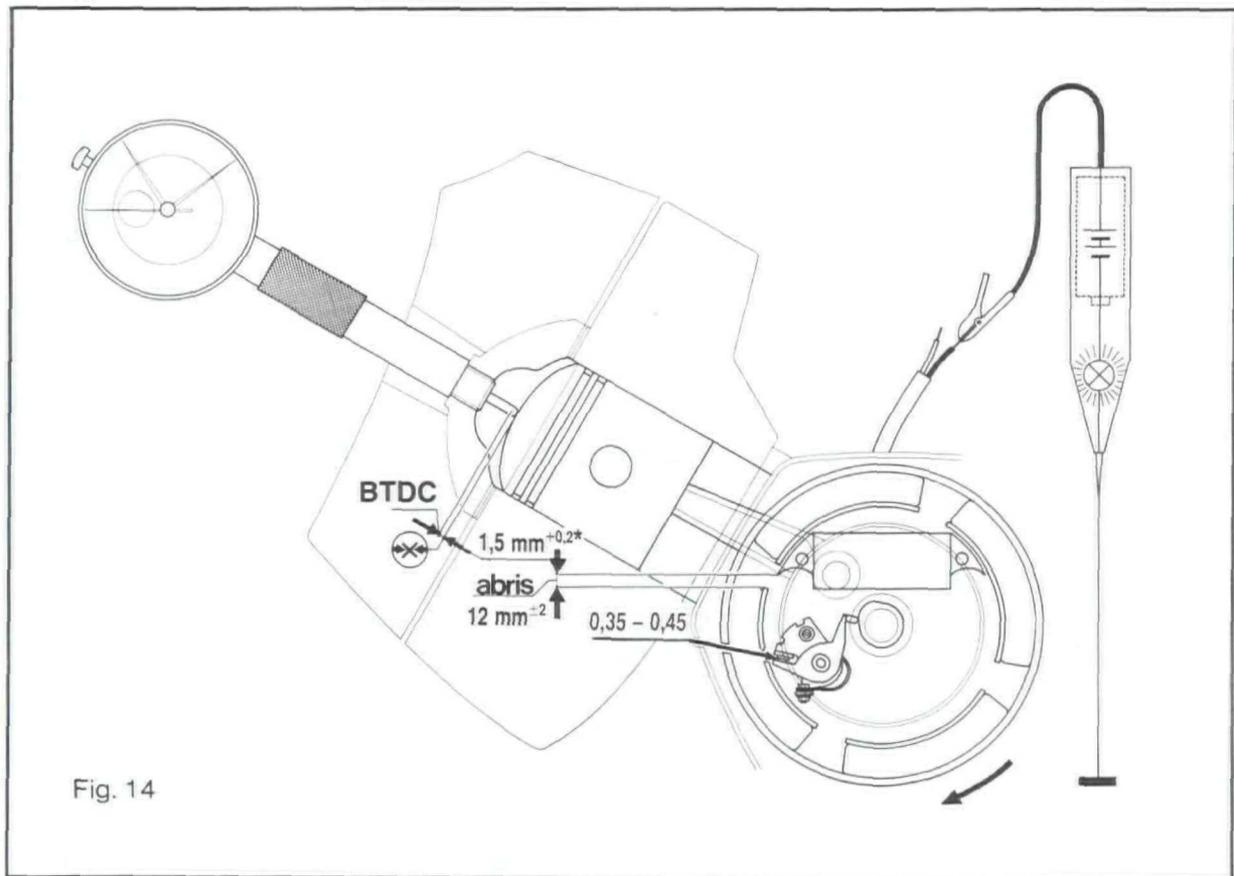
Fig. 14

For proper function of the engine is essential a correct ignition timing. The ignition advance should be $1,5^{+0,2} \text{ mm}^*$. The most common cause of incorrect timing is due wear or damage of contact breaker points, wear of cam actuated breaker nose lever, damage of condenser. To provide the exact timing is necessary to replace faulty parts and proceed (fig. 14) as follows:

- Screw the special tool 732.193 and dial gauge 975.709 with gauge pin 011.008 into the spark plug hole. By rotating the flywheel put the piston to the T.D.C. and set the dial gauge to zero.

- With the flywheel in T.D.C. set the contact breaker points gap between 0,35 to 0,45 mm
- With a test light, buzzer or Ohm meter determine when contact breakerpoints connection is made. The testing device must be connected to the short circuit (black) wire and to the ground of the engine. At the moment of connection of the points the test battery light will glow brightly, the buzzer will change the acoustic frequency or the Ohm tester will show approx. zero Ohms.

- Rotate the flywheel in the clockwise direction until the dial gauge will show the value of 1,5 mm
- By means of oblong fixing openings rotate the stator base plate and find a contact breaker points connection - opening position (test indication).

- Tighten the stator base plate and recheck the ignition advance which should be max. 1,7 mm
- In case of excessive advance, the stator base plate should be rotated in the direction of entire rotation (see arrow of flywheel). In case of insufficient advance turn the plate in the opposite direction.

- For efficient spark intensity or high ignition voltage is essential a proper abris adjustment. As a matter of fact, it is the distance between the edge of the ignition coil pole shoe and the receding magnet pole edge at the opening point of the contact breaker and it should be within the range of $12 \pm 2 \text{ mm}$ ($0,473 \pm 0,079 \text{ in}$). The gap should be measured the moment the intensity of light or sound frequency is changed on the gauge (fig. 14).

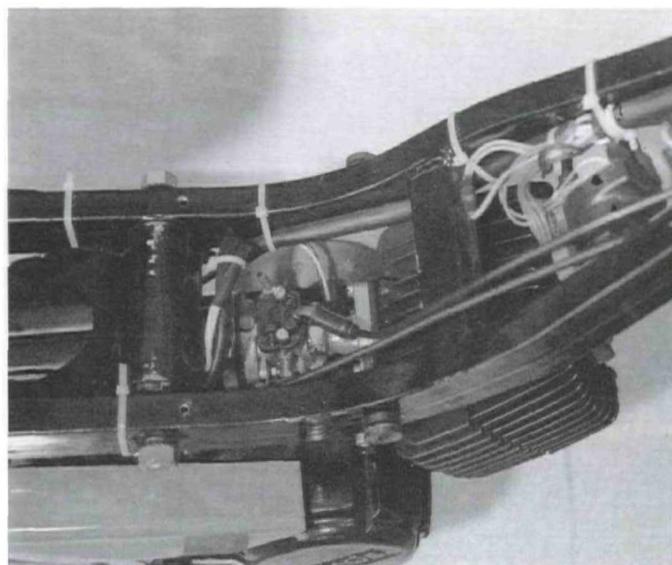
Fig. 16

- carburetor area protection shield (detach the rubber protection sheet, slackes the screwsflat screwdriver)
- fuel tank (screw on bottom side near horn attachment on frame and on rubber elements-box wrench 10 mm)
- carburetor cpl. with air filter and rubber dust protection (screw of fixing claw - flat screwdriver) fig. 16.

Remove the carburetor protection shield and fuel tank to easily work on HT igniton coil and horn (fig. 16).

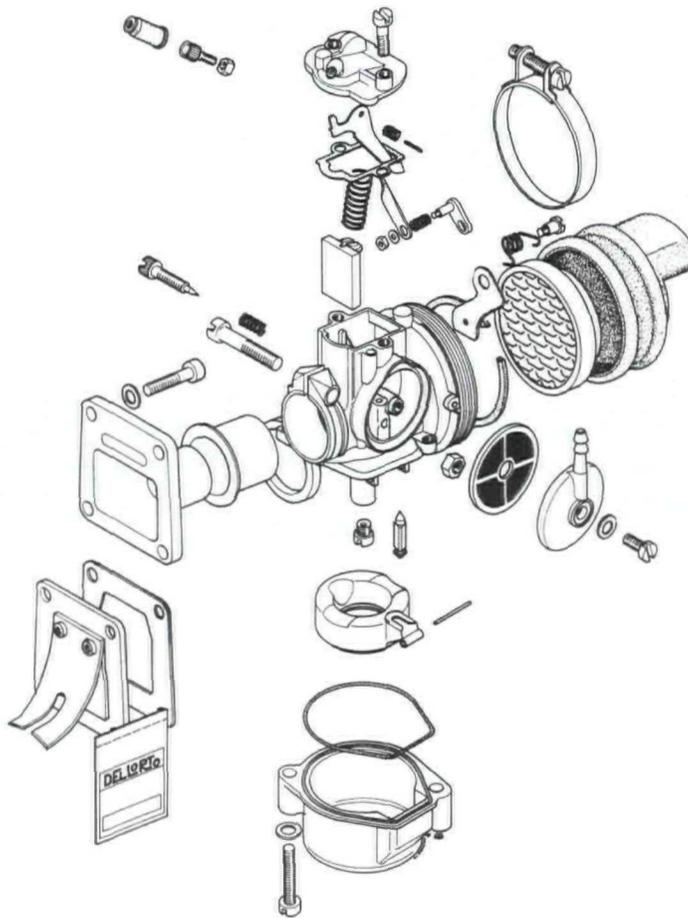
Dismantle the carburetor into component parts (fig. 17). Clean the parts in gasoline (petrol) and blow them by compressed air.

Replace if necessary worn parts and carefully reassemble, especially the needle valve and float. Slightly oil the air filter.

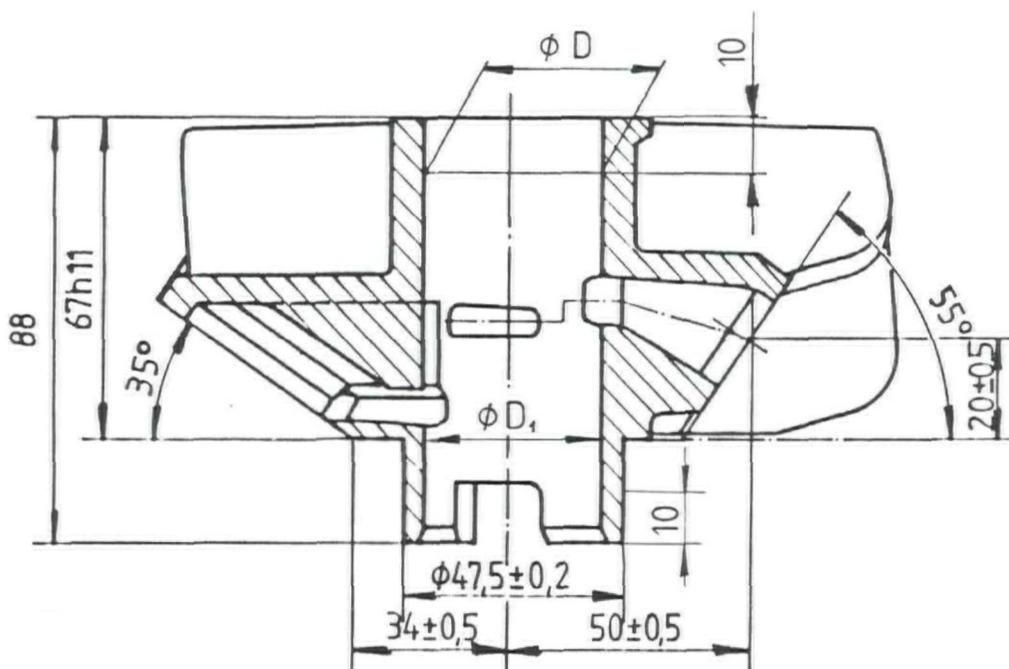
Bore taper and come-shaped:
 $D_1 = \text{max. } 0,012 \text{ mm } (0,473 \cdot 10^{-3} \text{ in})$

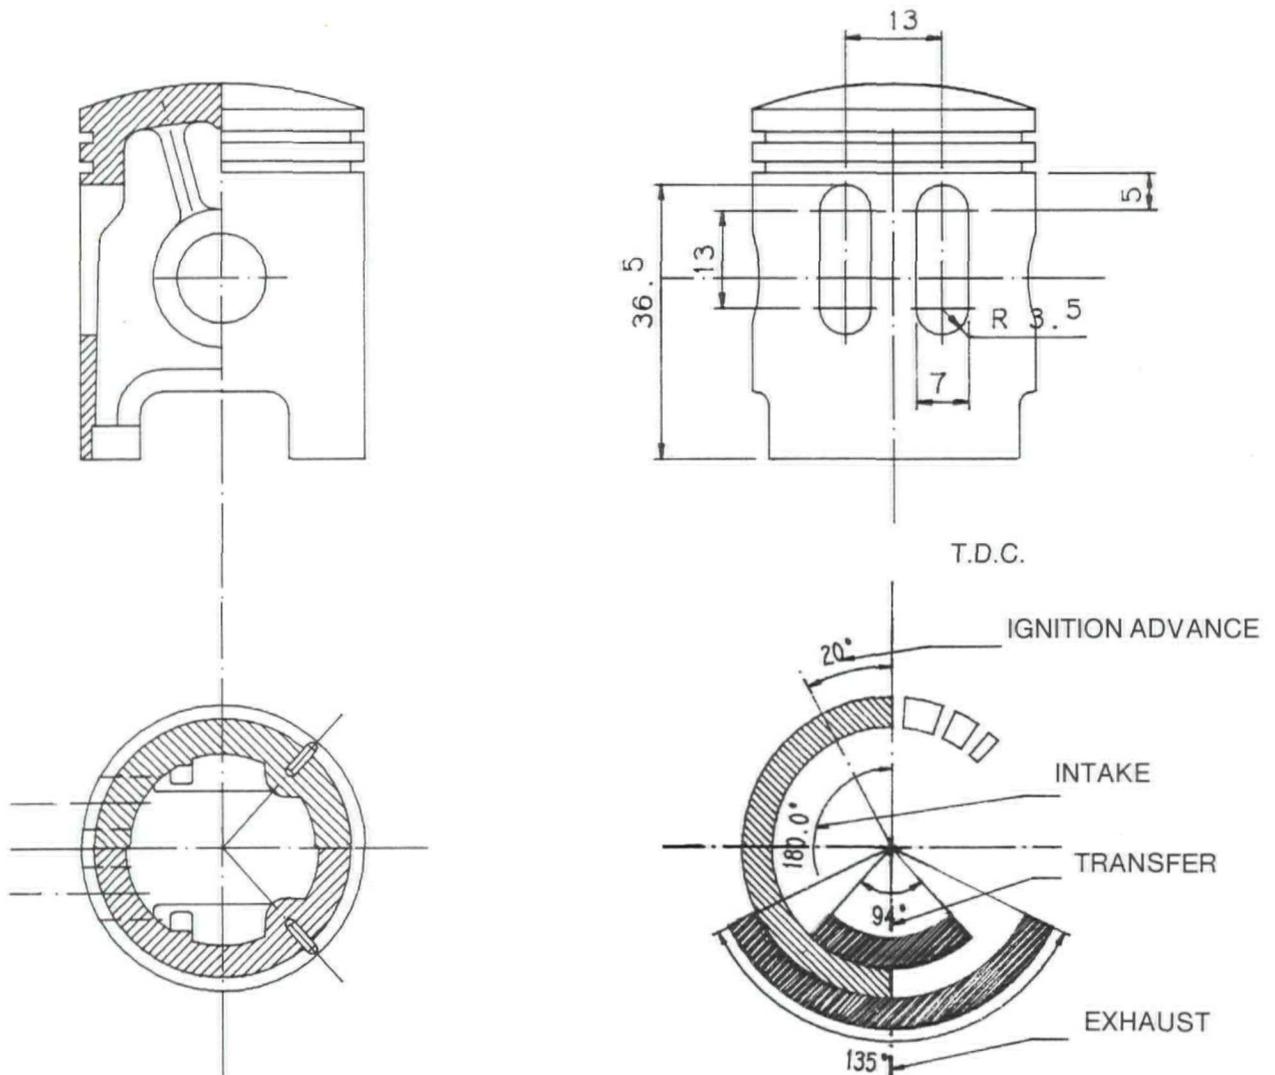
Fig. 20

Upon the request of the market there are available two different pistons: 50 km/h (30 m.p.h.) - fig. 20 and 40 km/h (25 m.p.h.) - fig. 21 with their own function diagram.

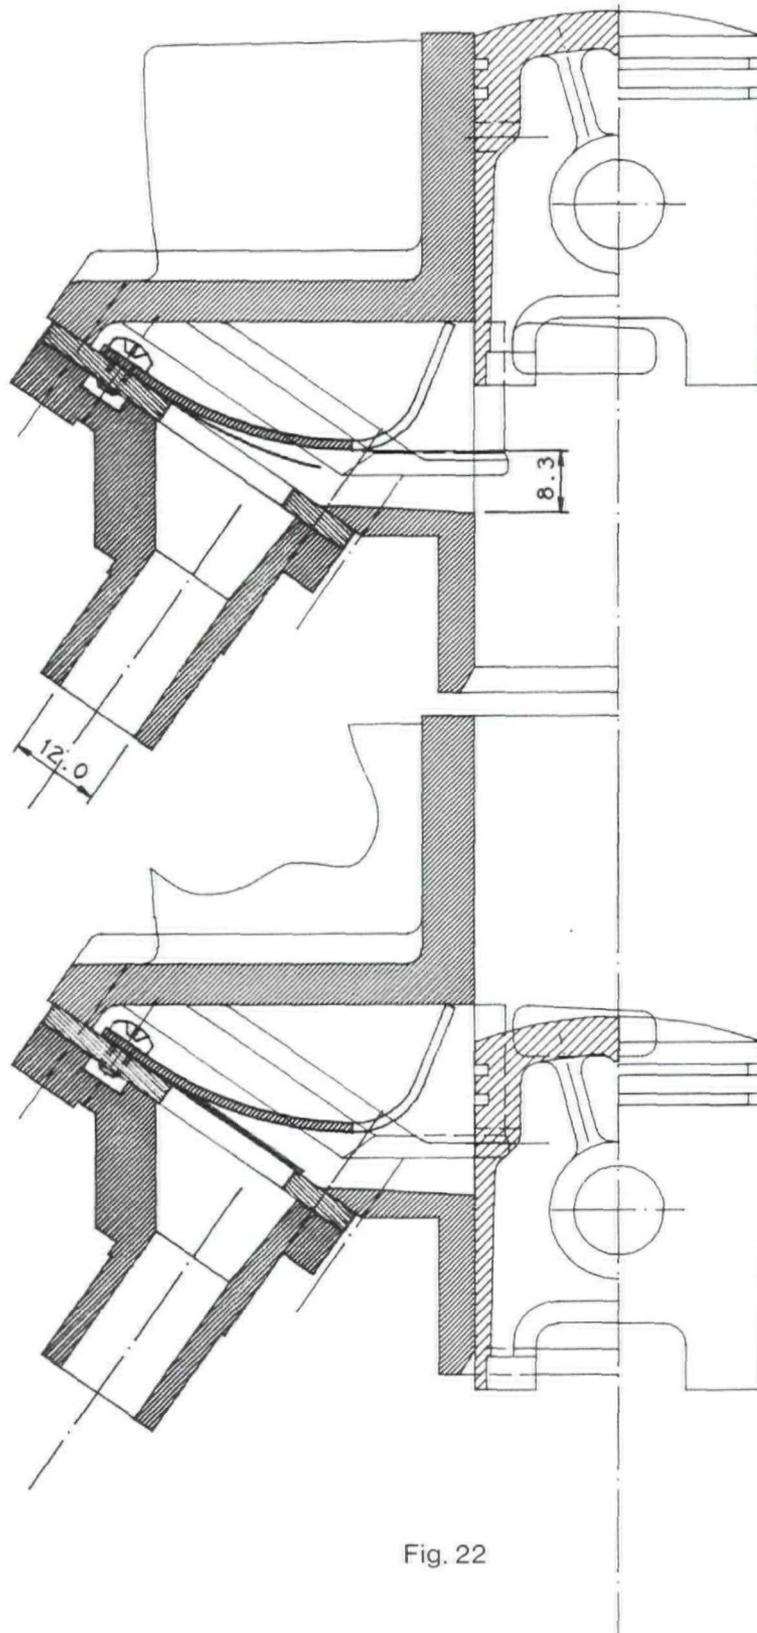
Fig. 22

Damage to reed valve may be caused also by steel material run-down (see function on fig 22, assy. parts - fig.23).

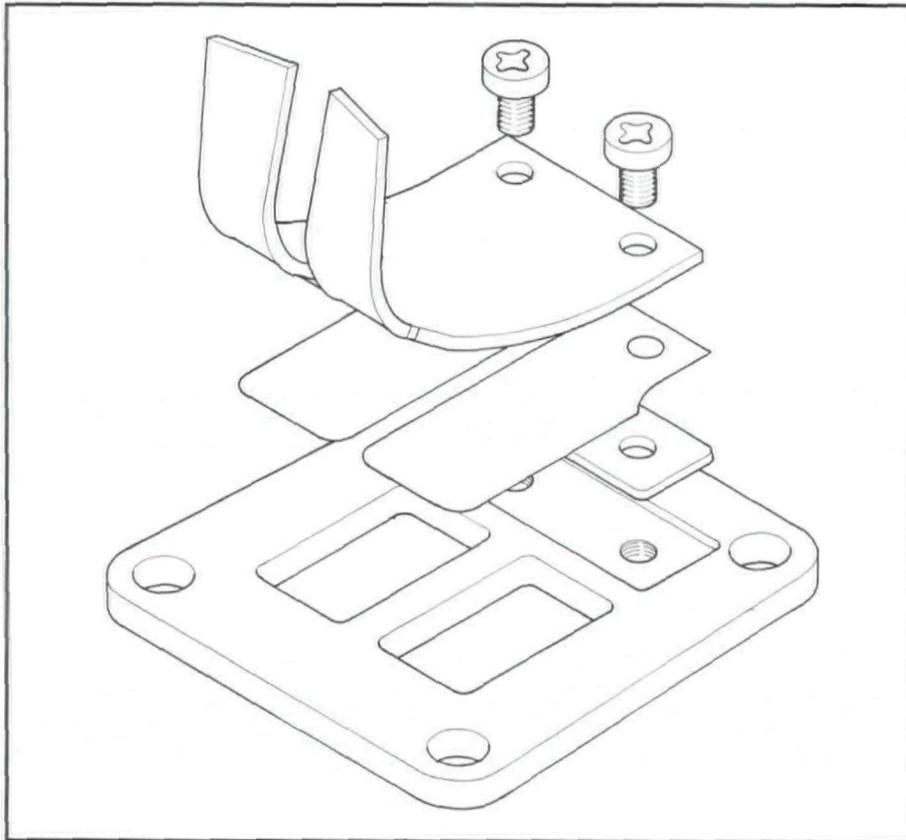
Fig. 23

NOTE:
Replacement of cpl. reed valve is suggested.

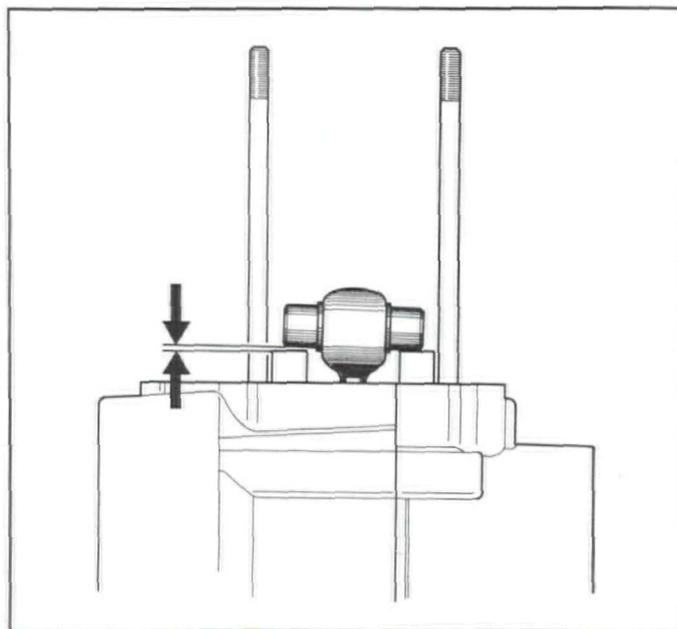
Fig. 24

Check conrod bending by help of two calipers (Fig. 24). Check the needle bearing clearance and bearing rolling surface for damage.

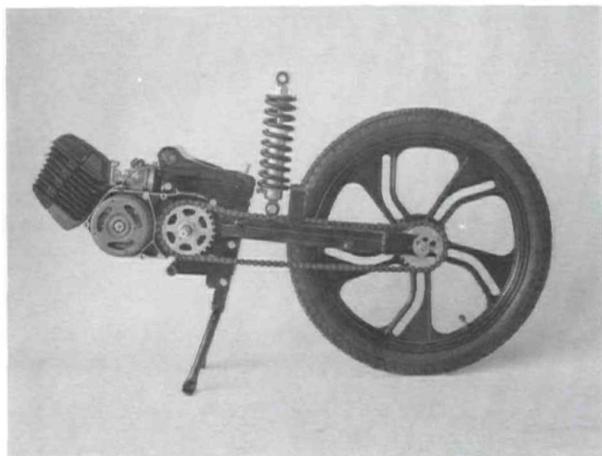
Fig. 25.

In case of mentioned repairs is necessary to dismantle the engine from the fixing supports of swinging arm assy. (fig. 25).

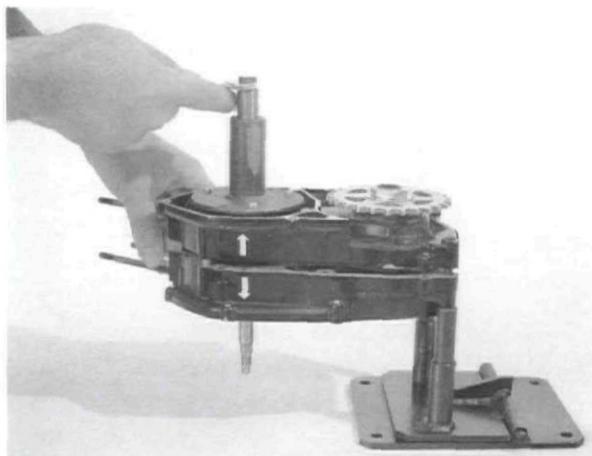
Fig. 26

Install on the magneto side a case splitter tool 735.888 with the three magneto base plate fixing screw. With wrench 13 mm screw on the device A and detach both halves (fig. 26).

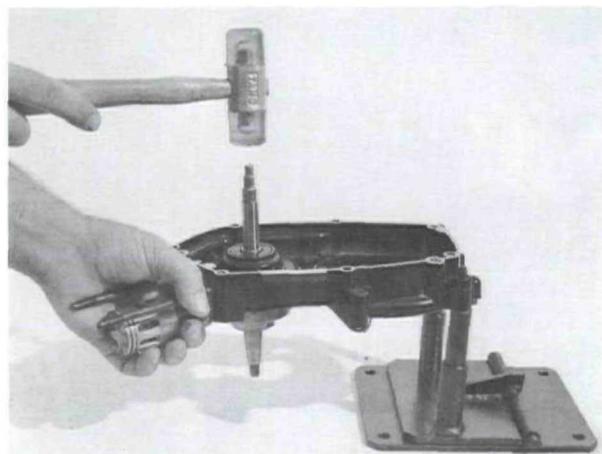
Fig. 27

Detach the crankshaft from the RH crankcase half with a plastic mallet (fig. 27). In case of remaining ball bearing on the crankshaft remove it with the extractor 731.155 (fig. 28).

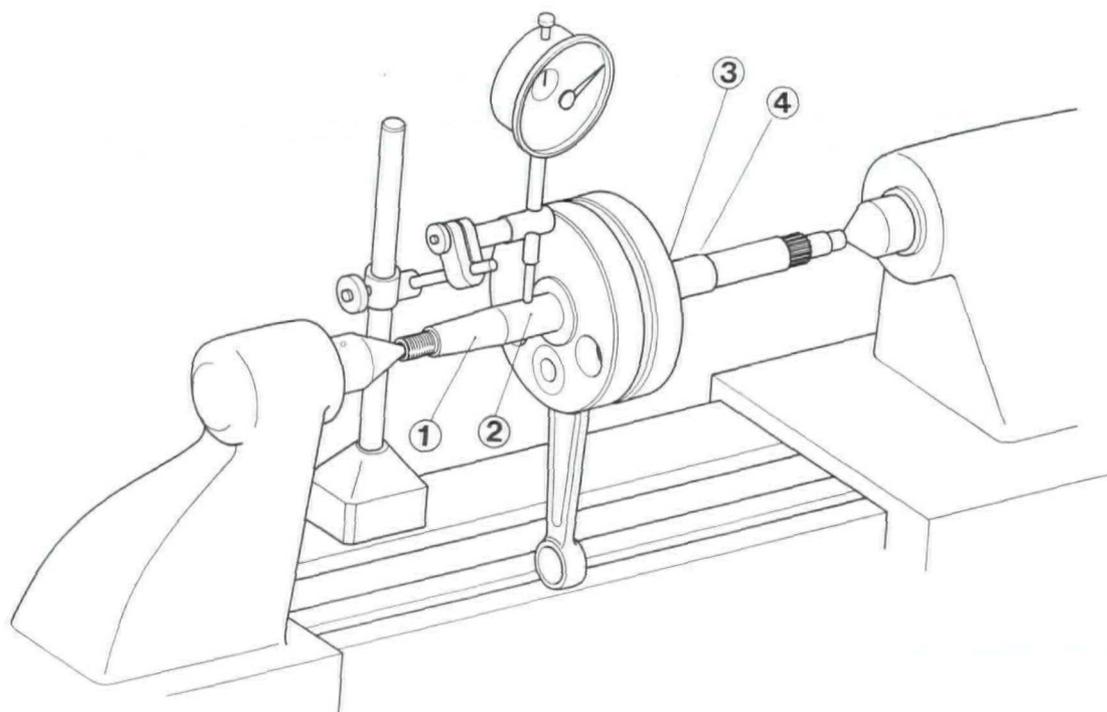
Fig. 29

Check the crankshaft between the center of a horizontal alignment tool and measure the out-of-round on all the points indicated in fig. 29.

Permissible out-of-round should be within 0.02 mm (0.008 in) at check points 2 and 0.01 mm (0.004 in) at check points 1 and 4. Check if the crankshaft conical part is damaged, inspect the thread on semiaxles and the key-way.

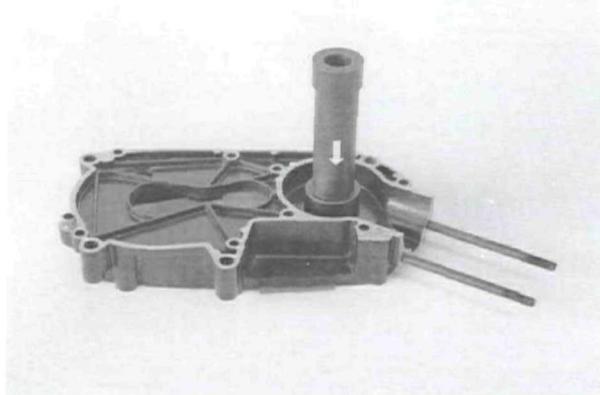
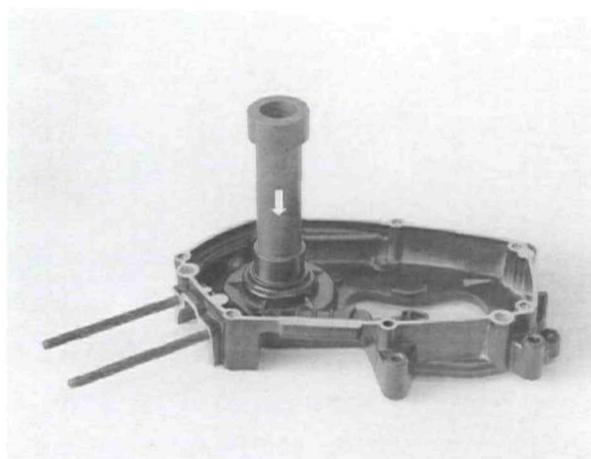
Remove seal rings by screwdriver. For disassembly of ball bearings and seal rings assembly alternatively use a pressing pin 702.856 (fig. 30 and 31).

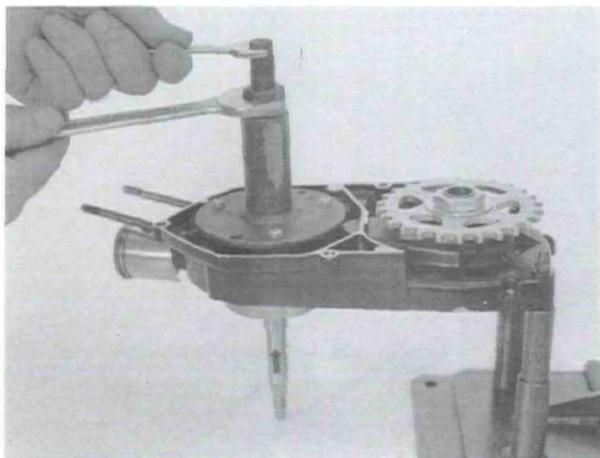
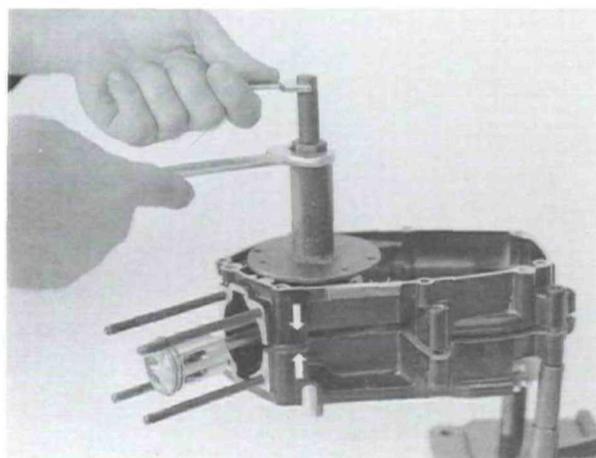
Crankshaft is impressed in crankcase halves by extractor 735.888 actuating with screw B (fig. 32 and 33) - wrench 24 and 13. In case of machine press assembly is necessary a use of crankshaft insert forks 735.753 to prevent crankshaft deflection.

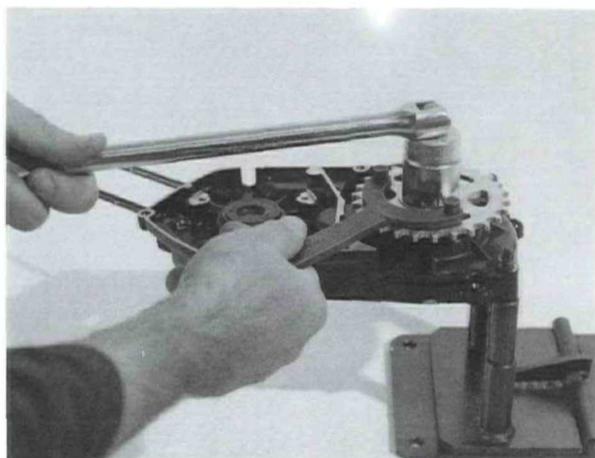
Fig. 34

In case of mainshaft tooting damage replace it. Slacken the chain sprocket nut by a wrench 30 mm and using the special tool 732.202 (fig. 34). Knock out the mainshaft by plastic mallet.

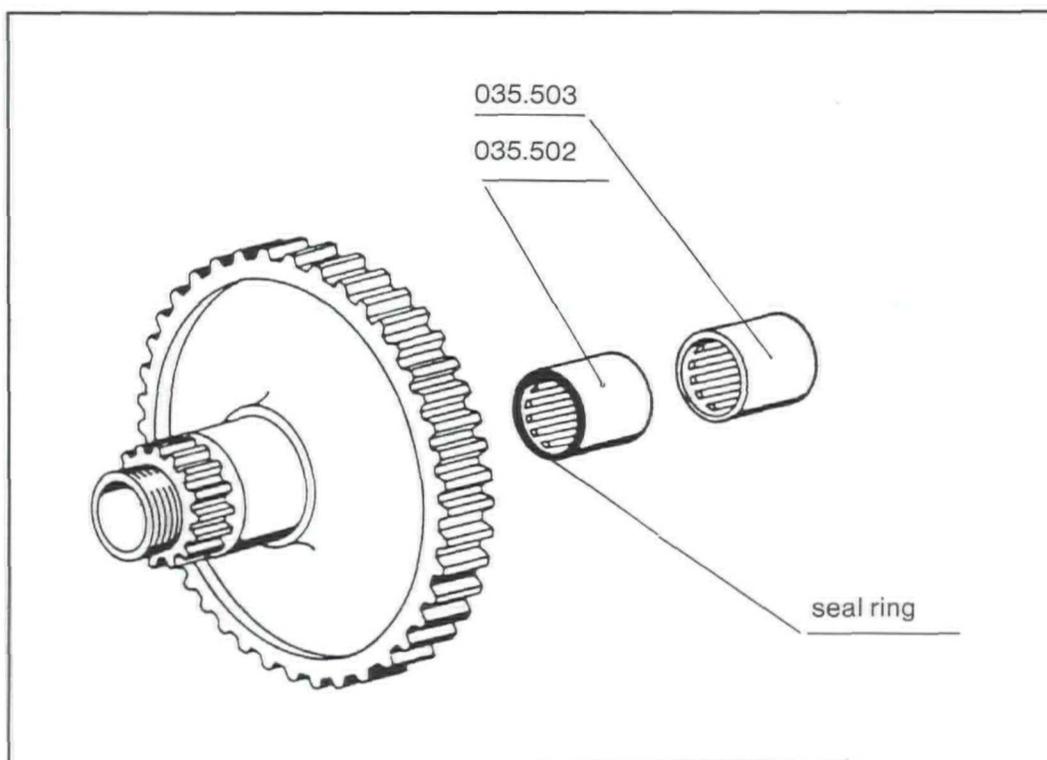
In case of needle bearings or seal ring (incorporated in first needle bearing, code 035.502) damage knock out them by suitable tool but pay attention not to damage bearing lying surface on mainshaft. Pay attention on sequence assembly of needle bearings (fig. 35) by machine press tool and special tool 732.367.

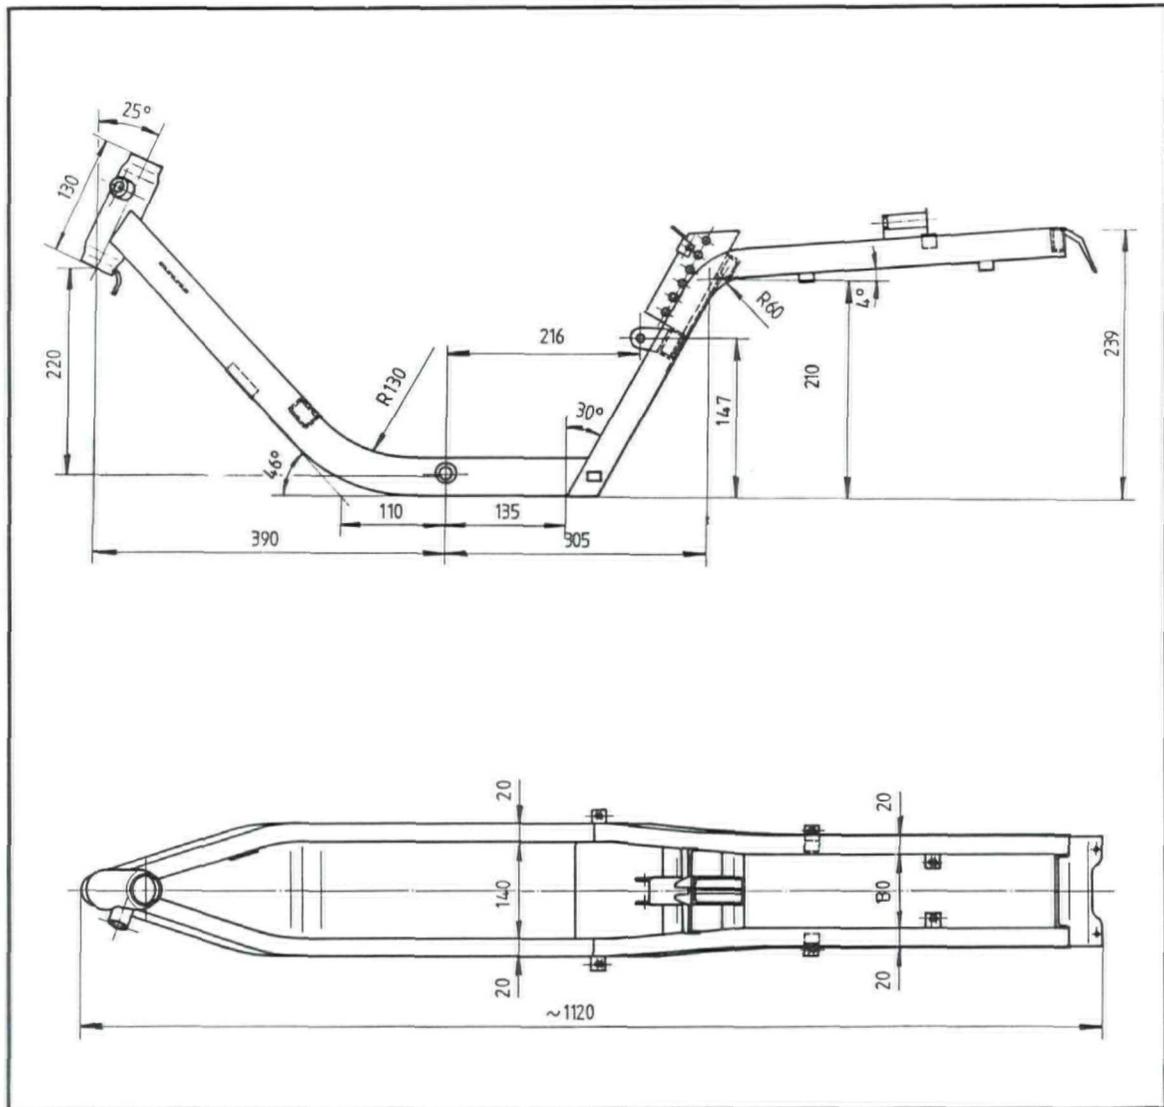
Fig. 36

The frame is rectangular steel tube construction type (fig. 36). Engine is peculiarly incorporated with supports in rear swinging arm with hydraulic monoshock absorber (fig. 37 and 25). Front forks are common telescopic-spring type (fig. 38).
