TOMOS A35

workshop manual

colibri
TOMOS A35

TOVARNA MOTORNIH VOZIL
TOMOS KOPER
SLOVENIA

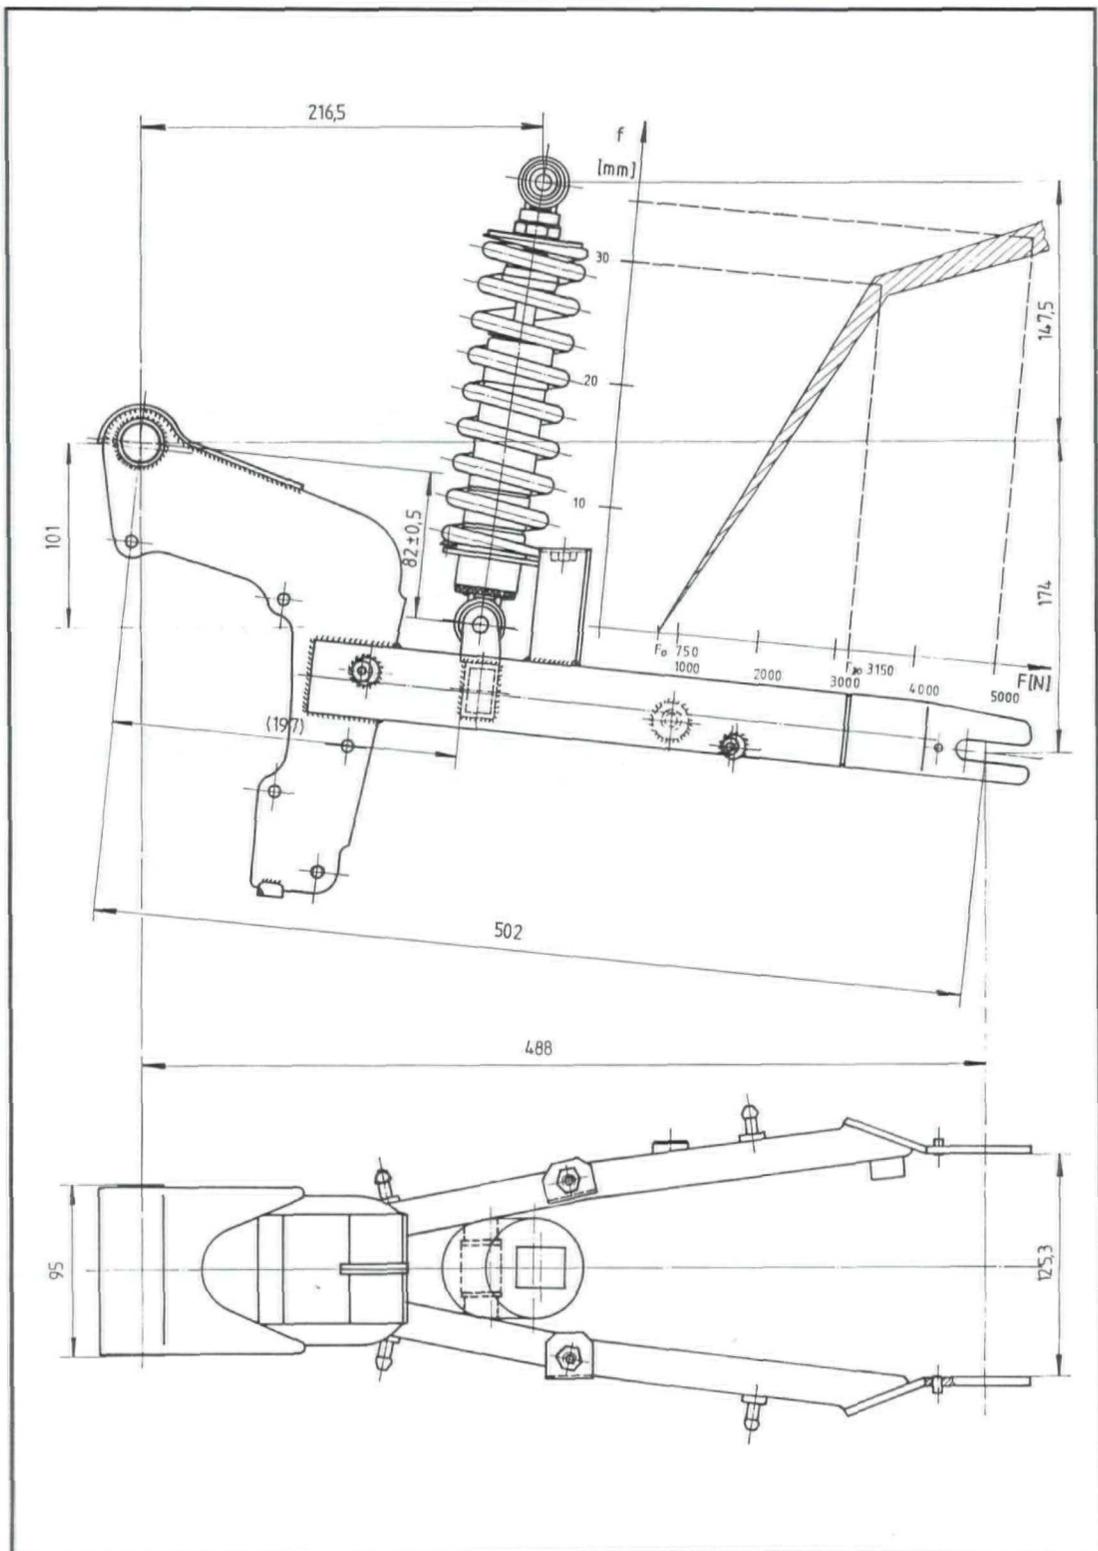
Fig. 37

The frame is rectangular steel tube construction type (fig. 36). Engine is peculiarly incorporated with supports in rear swinging arm with hydraulic monoshock absorber (fig. 37 and 25). Front forks are common telescopic-spring type (fig. 38).

For a safe riding is necessary that here is none excessive clearance in front and rear forks assy. which is obtainable with tightening of steering bearings and replacement of sliding bushing at swinging arm. In case of hydraulic monoshock absorber damage do not try to open the hydraulic part of assy. because is under high pressure thus replace the monoshock absorber cpl.

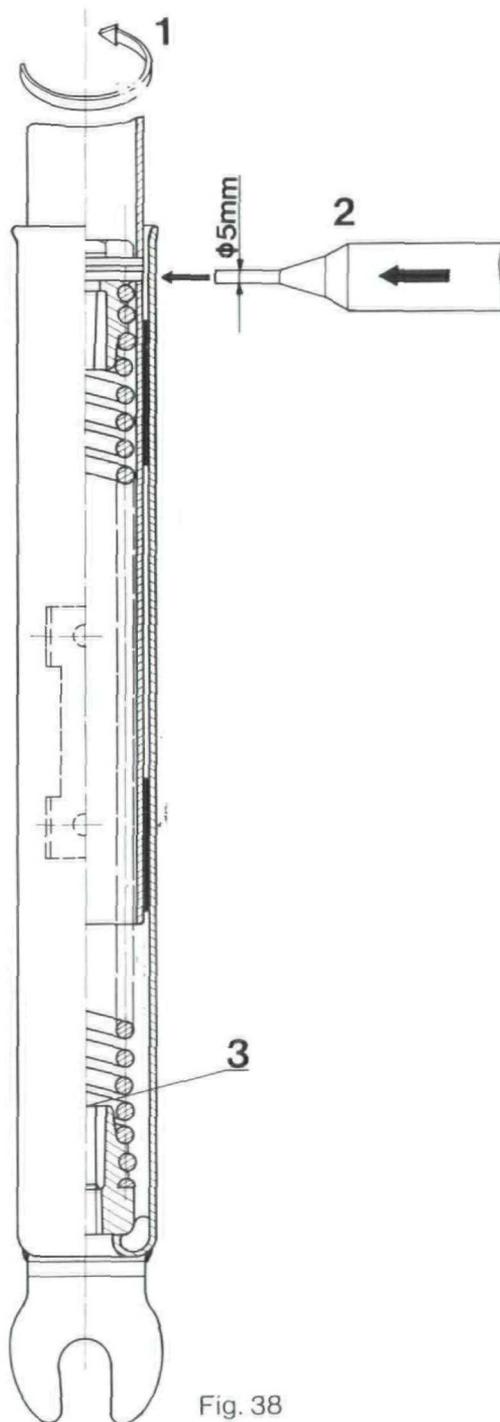
Fig. 38

The front fork lower leg can be removed as it is shown in fig. 38.

- by unscrewing remove lower leg from the front fork (fig. 38/1)
- the spring will remain attached either to the upper or to the lower screwed plug - remove by unscrewing
- the upper plug should be removed after taping out the elastic pin (fig. 38/2)
- the lower plug can be removed with longer allen key (9 mm), (fig. 38/3)

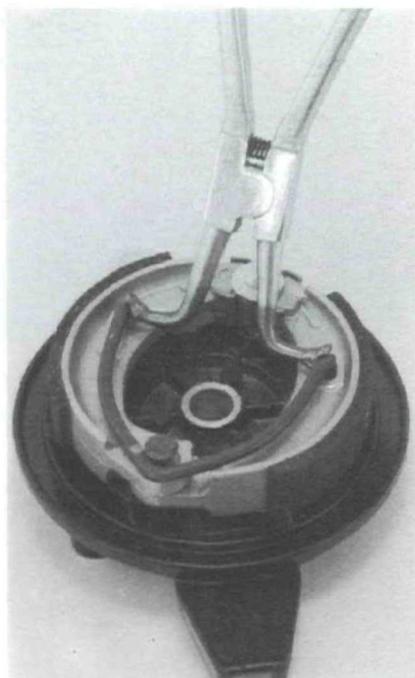
Fig. 39

Brakes are drum type (fig. 39) thus there is a periodically need of linings dust (non asbestos) cleaning; cable controls, brake operating cam and brake shoes support pin greasing. Disassembly of brake shoes is easier with pliers - special tool 736.913.
